**CASE STUDY:  
CONDITION  
ASSESSMENT**

**CONDITION ASSESSMENT OF  
ASBESTOS CEMENT WATER MAINS,  
CITY OF SAN DIEGO, CALIFORNIA**

**Report Created By:** Mr. Bhaskar Dasari, Virginia Tech

**June, 2015**

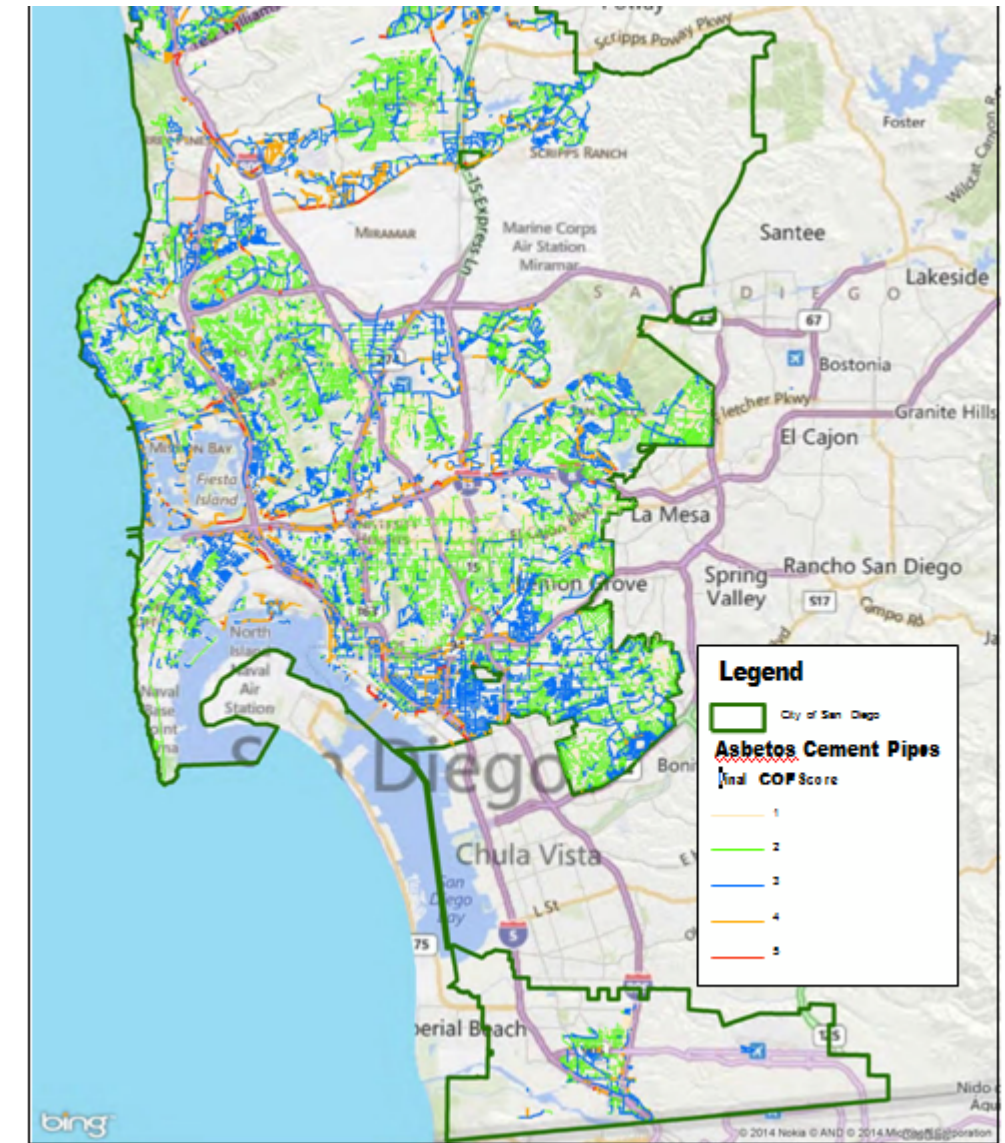
Figure 3: COF Results Map

Based on the available data sources, a scoring criteria was developed for each consequence of failure factor. The first step involves grouping of factors into three categories of increasing criticality: 1 = Low, 2 = Medium and 3 = High Consequence of failure. The highest score in any criteria then becomes the pipe initial COF score. In a second step, the score is increased through addition up to 5 if more than 1 criterion has medium or high scores for any single AC pipe. Additional distinction among the high critical pipes is achieved through this method and also the scoring range is expanded to 1 to 5. Tables 1 - 8 defines the COF Criteria results of the parameters and Figure 3 depicts the COF Results map.

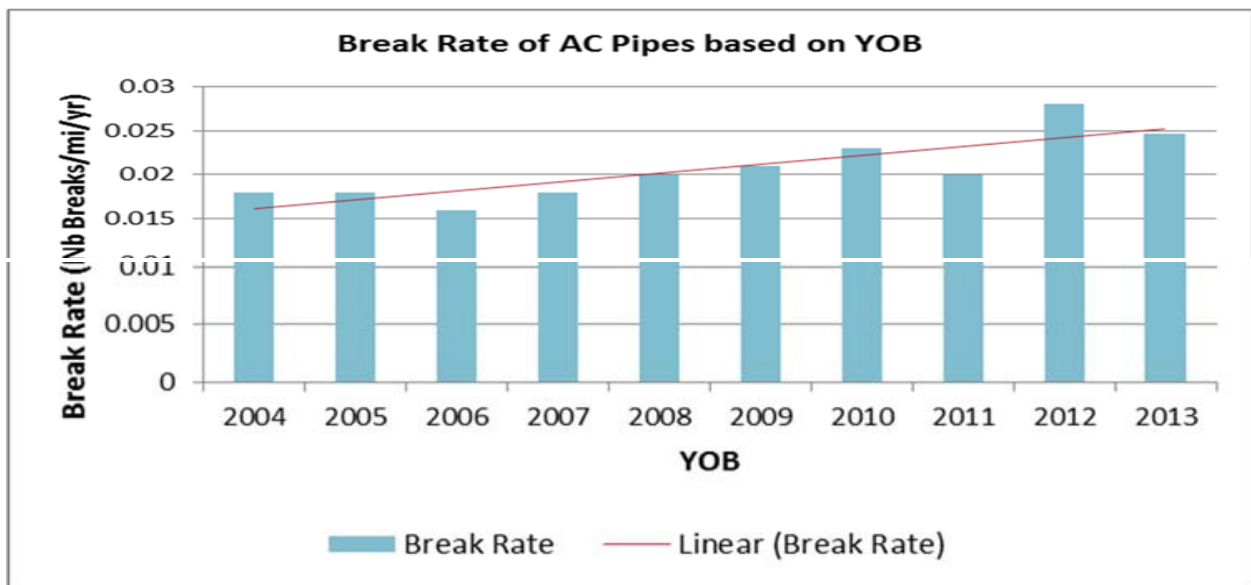
**Figure 4: Break Rate of AC Mains Based on YOB(420 Breaks)**

- AC mains have broken between 1 and 7 times and 98.7% of the mains have never broken at all. Figure 4 below shows the break rate every year since 2004.

- The break rate has been increasing over time.

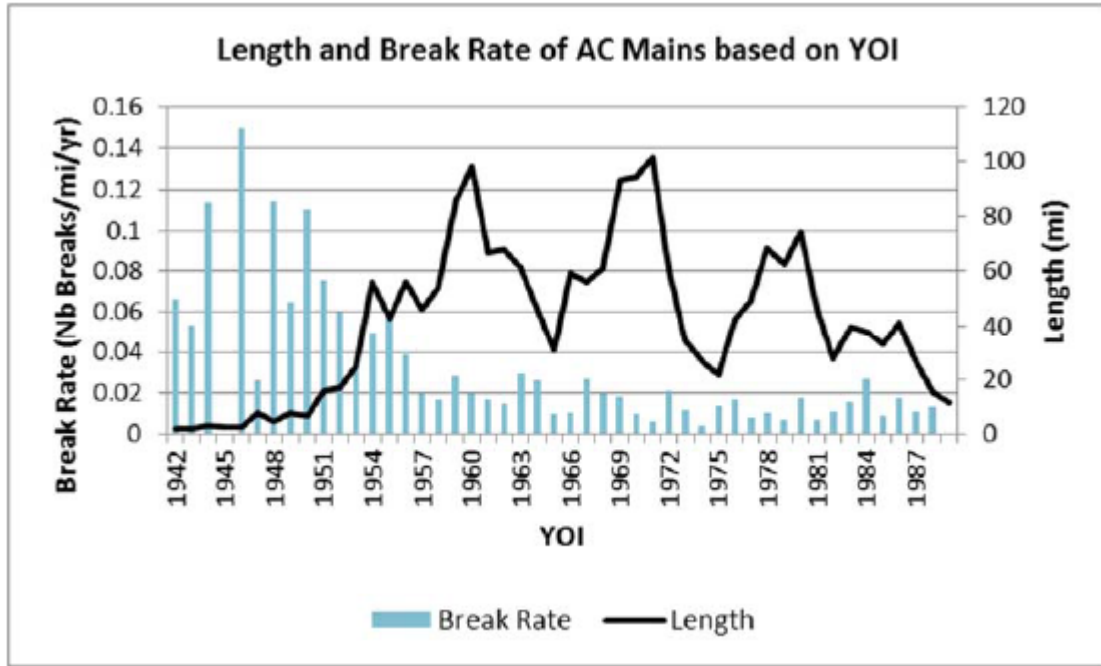
Figure 5: Length and Break Rate of AC Mains Based on YOI (420 Breaks)

The majority of the AC main installation has occurred between 1950 and 1990. The break rate is shown to depend on whether the mains were installed before or after 1956. The rate is much higher on mains installed on or before 1956. Figure 5 shows the Break Rate based on YOI.

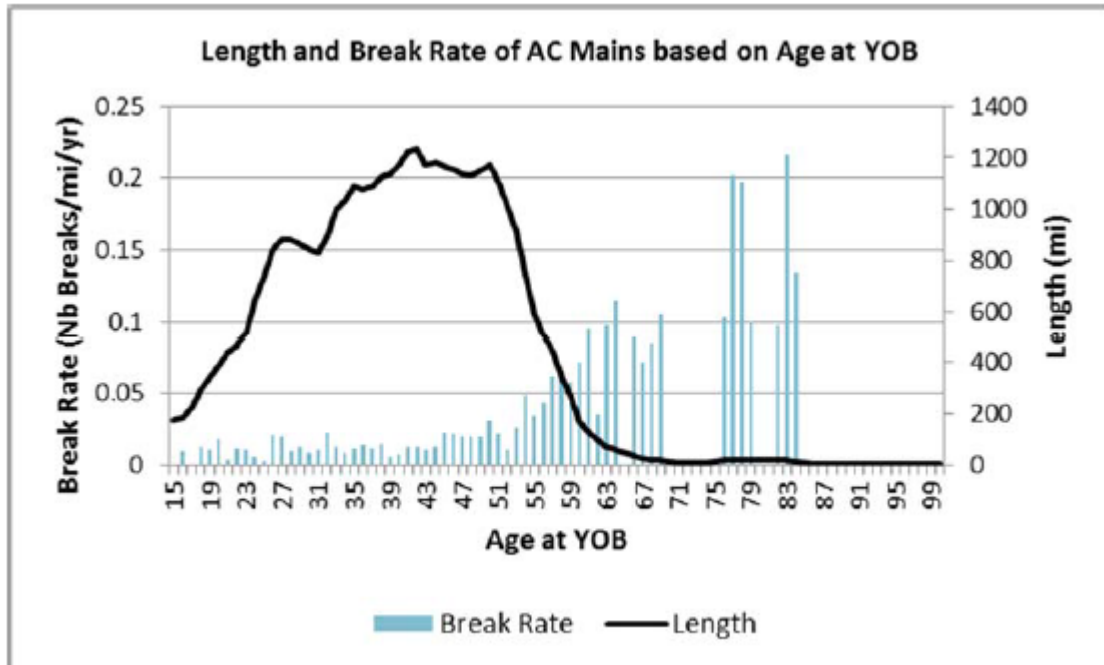
**Figure 6: Length and Break Rate of AC Mains Based on Age at YOB (420 Breaks)**

The last of the AC mains in the system were installed in 1990. By 2004, date of the first observation of breaks, the mains installed in 1990 was 14 years old. Therefore, Figure 6 starts at 14 years of age. Between the years 2004 and 2013 (period of observation of the breaks):

- Approximately 158 mi of mains reached the age of 14 with a break rate of 0.
- Approximately 1,200 mi of mains reached the age of 42 with an average break rate of approximately 0.01 break/mile/year or 1 break/100 miles/year.

Figure 6 shows that the break rate is around .015-breaks/ mile/year or 1.5-breaks/100 miles/year for mains between 26 and 45 years. It starts to increase after 45 years (which is the average age of AC mains in 2013). And by 64 years, the break rate has increased to 0.1 breaks/mile/year.

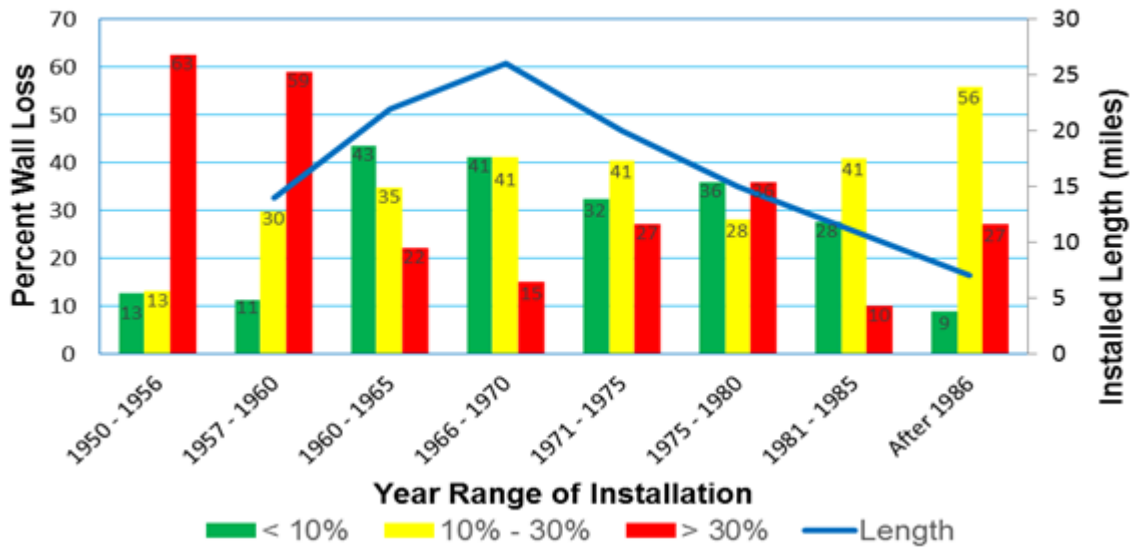
**Figure 8: Year of Installation Vs. Effective Wall Loss**

The following conclusions are drawn from the Phase 1 testing results of large diameter mains:

The following recommendations were used to develop a replacement plan for large diameter pipes:

- An Effective Useful Life (EUL) of 70 years is used for all large diameter Type I mains so that they are considered first in the replacement program.
- For Type II large diameter mains, published EUL values of 87 to 118 years (based on internal pressure) are used.
  - Since higher degradation was seen in the southern regions (Downtown, National City and San Ysidro), a EUL of 87 years is used for these areas.
  - Similarly, newer mains installed after 1981 also exhibited higher degradation and are assigned of a EUL of 87 years.
  - Mains on Urban soils indicated higher degradation and are assigned a EUL of 87 years.
  - All other Type II large diameter mains are assigned an EUL of 118 years
