**CASE STUDY:  
CONDITION  
ASSESSMENT**

**PILOT ACOUSTIC CONDITION ASSESSMENT  
OF WATER DISTRIBUTION SYSTEM,  
WASHINGTON SUBURBAN SANITARY  
COMMISSION (WSSC), MARYLAND**

**Report Prepared By:** Ms. Sowmya Bhimanadhuni, Virginia Tech

**December, 2014**

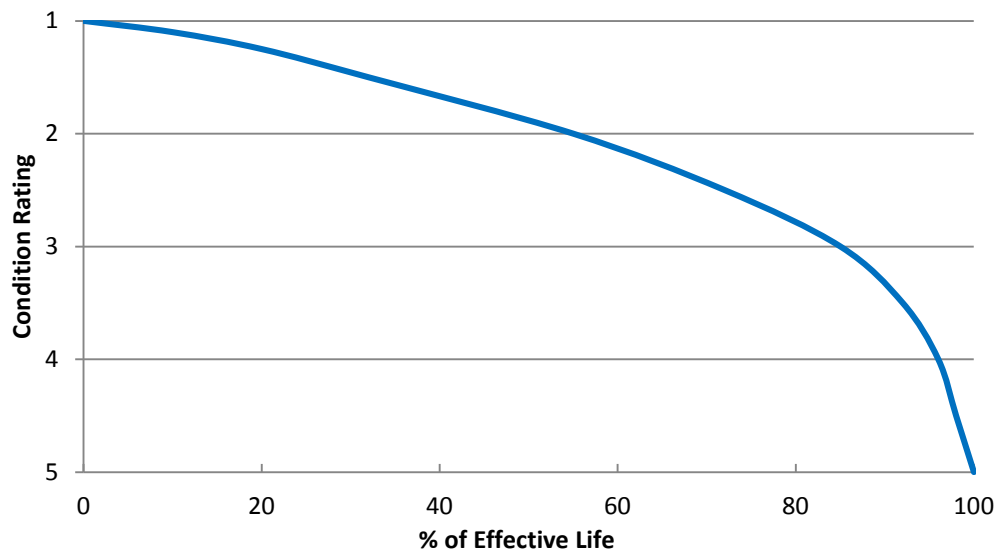
Figure 5: Example of a Decay Curve generated by AM model

- AM model calculates mathematical decay curves for pipes using the following factors:
  - Construction year
  - Rehabilitation date
  - 15 year break history
  - 5 year break history
  - Lining presence
  - Lining installation year
  - Fire flow results

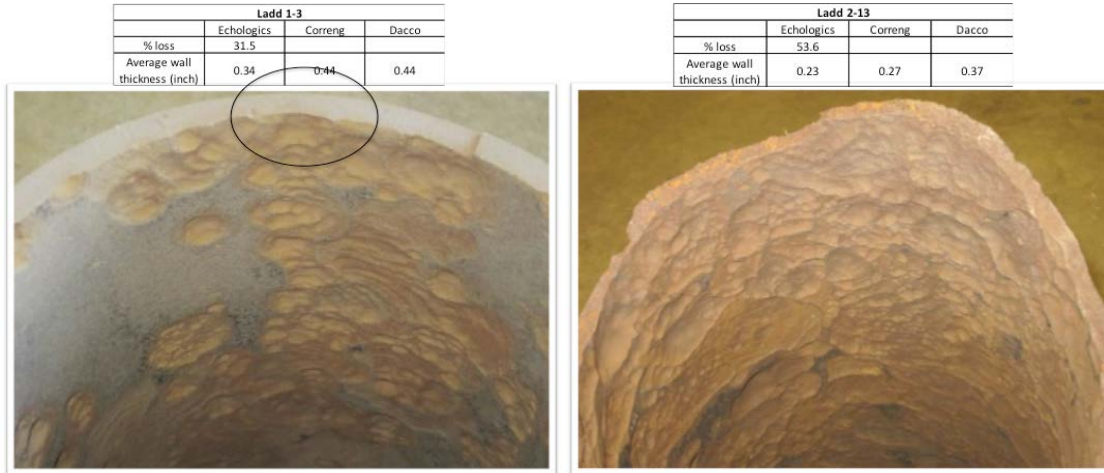
Figure 10: The remaining wall thickness measurements of adjacent pipe segments made using acoustic testing and two forensic analysis. The acoustic test rightly tracked which pipe had a lower remaining wall thickness.

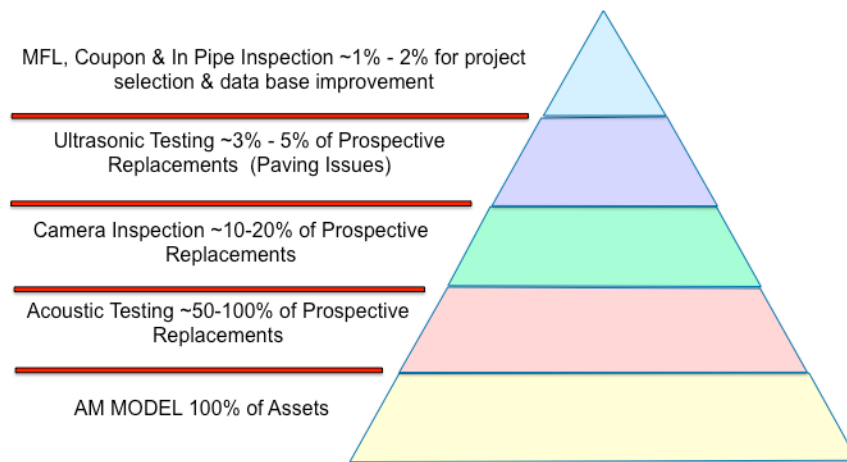
Figure 12: Proposed Pipe Inspection Program

After a detailed accuracy comparison, cost comparison and benefit analysis of the condition assessment options, a PIP was designed to better prioritize pipes in future replacement projects. The PIP was proposed based on the assumption that all pipelines can be grouped into cohorts based on their time, material, class and lining status and hence their 100 percent testing will not be required. Figure 12 shows the proposed test ratios of the PIP. The updated AM model revised using the pilot test results is being used to recommend pipes for subsequent NDT testing. Figure 13 depicts the recommended selection procedure for future water main replacement projects.

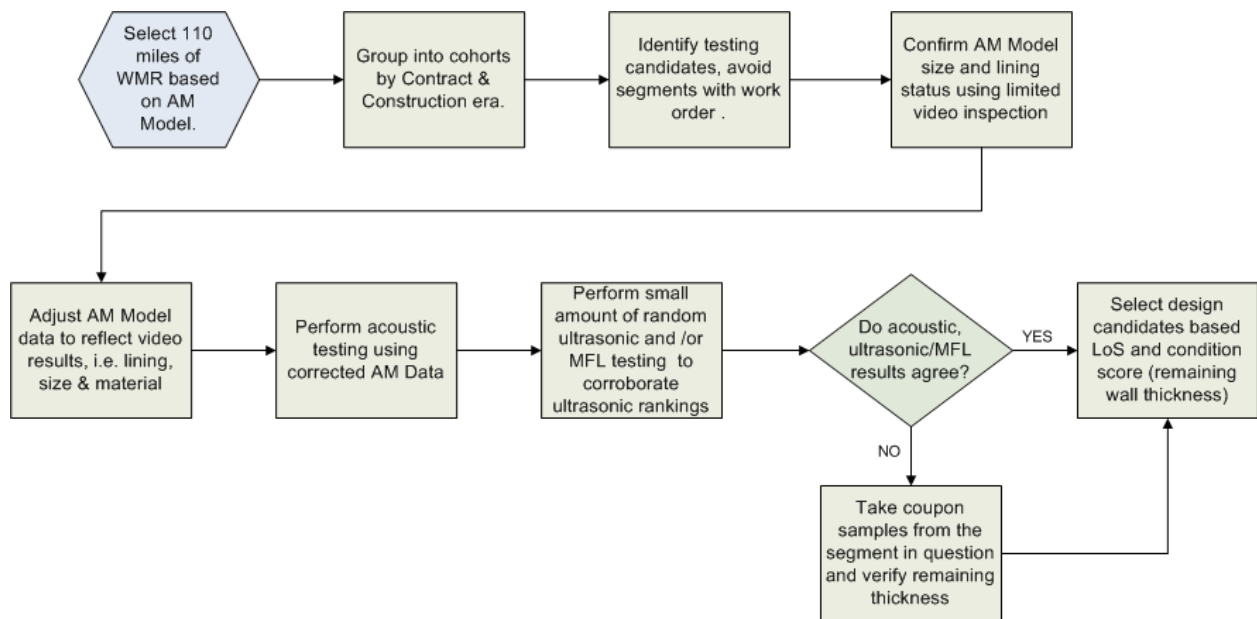
Figure 13: Flow chart showing the selection procedure recommended for future water main replacement projects
